HANDLING THE TYPE C PACKAGE TUK-145/C DURING SPENT FUEL REMOVAL FROM DNRI RESEARCH REACTOR, VIETNAM

S. Kashkirov, S. Komarov, A. Ivashchenko
Sosny R&D Company

The paper describes the work on preparation and implementation of the spent fuel removal.

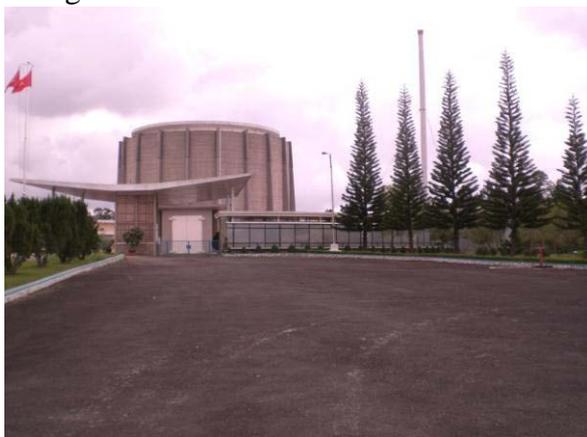
Fig. 1. DNRR reactor

Dalat is located in the south of the Socialist Republic of Vietnam, 1500 km from Hanoi and 300 km from Ho Chi Minh City. This is the home place for Dalat Nuclear Research Institute (DNRI). The Dalat Nuclear Research Reactor (DNRR) is a pool-type 500-kW research reactor with a light water moderator and coolant consuming the Russian fuel VVR-M2.

a – outside view

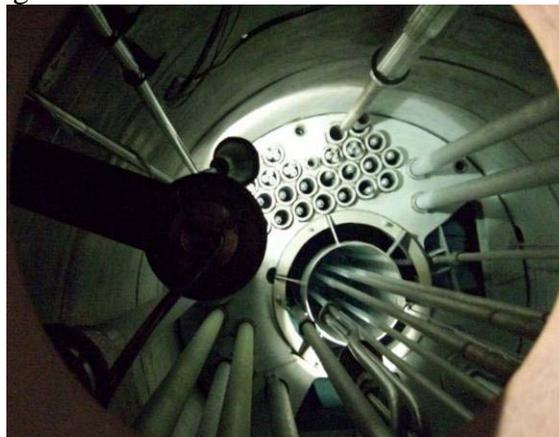
b – reactor pool

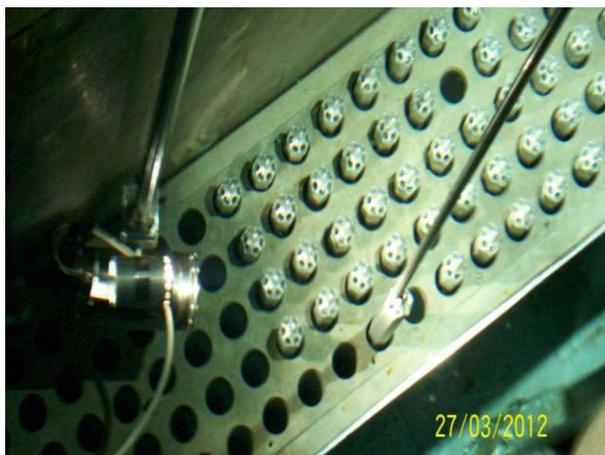
a – HEU SFAs in the storage pool

Fig. 2. VVR-M2 fuel rods

the reactor core. In October, 2011, 106 irradiated HEU fuel assemblies were reloaded from the reactor pool into the spent fuel storage pool.

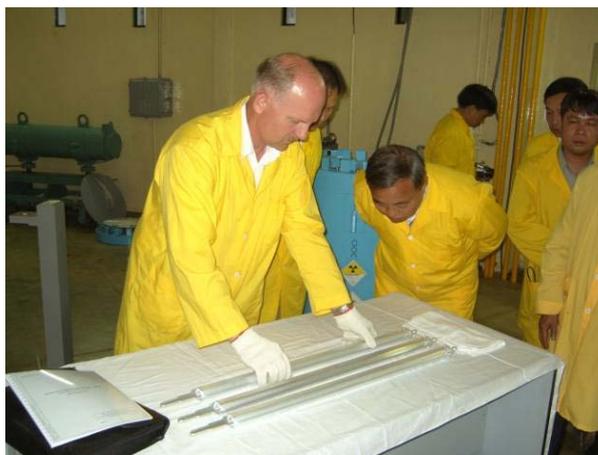
b – LEU VVR-M2 FAs

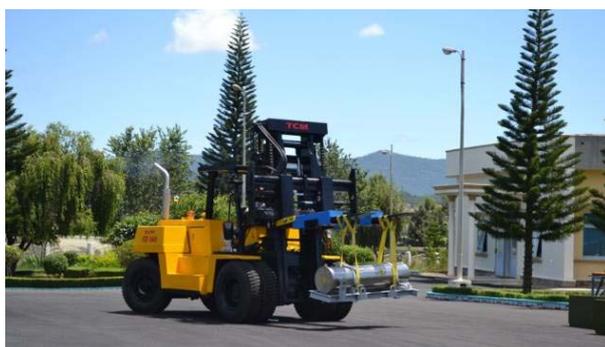
Fig. 3. Handling the equipment and SKODAVPVR/M cask

Following the requirements to the facility infrastructure, the areas for loading the spent fuel into the transfer and shipping casks were provided with the main power supply and a backup system powered by a diesel generator. Enhancements were made to the polar crane in the reactor hall, and a jib crane was additionally installed to shorten the fuel loading time and to ensure safety of the operations. The equipment, developed and fabricated in Russia, was shipped to the Institute by sea in ISO containers. A horizontal ground was prepared for handling them there. A 16-ton capacity forklift was procured to deliver the SKODA VPVR/M cask to the reactor hall.

a – unloading the equipment

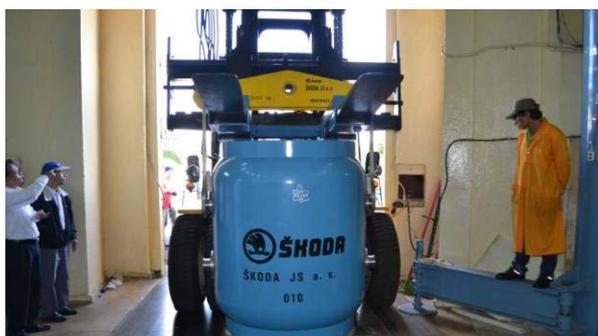
b – delivering SKODAVPVR/M cask to the reactor hall

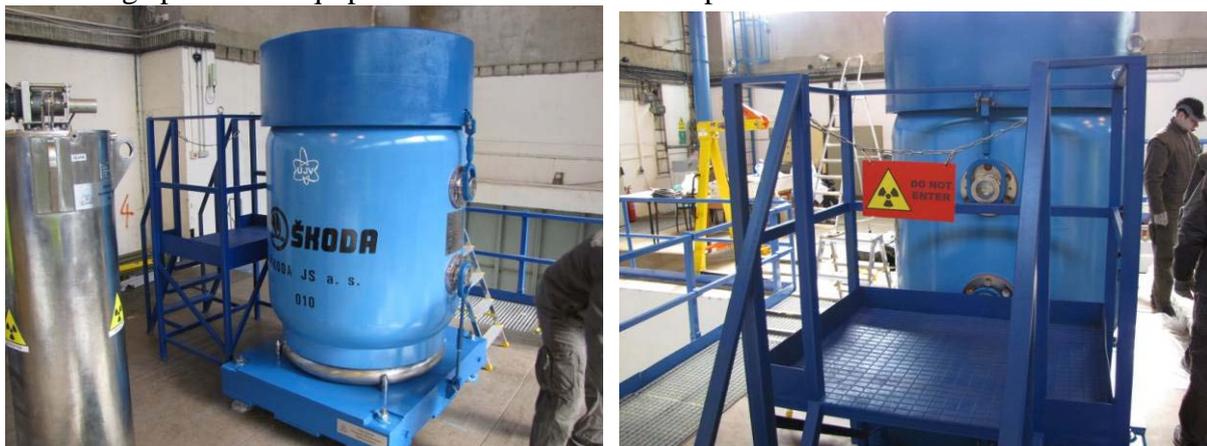
Fig. 4. Equipment installation at UJV

On completion of fabrication, all equipment units were delivered to the experimental site in Dimitrovgrad, Russia, which had the structure approximated to the parameters of the DNRI spent fuel storage pool. The equipment was installed and its performance tests were carried out.

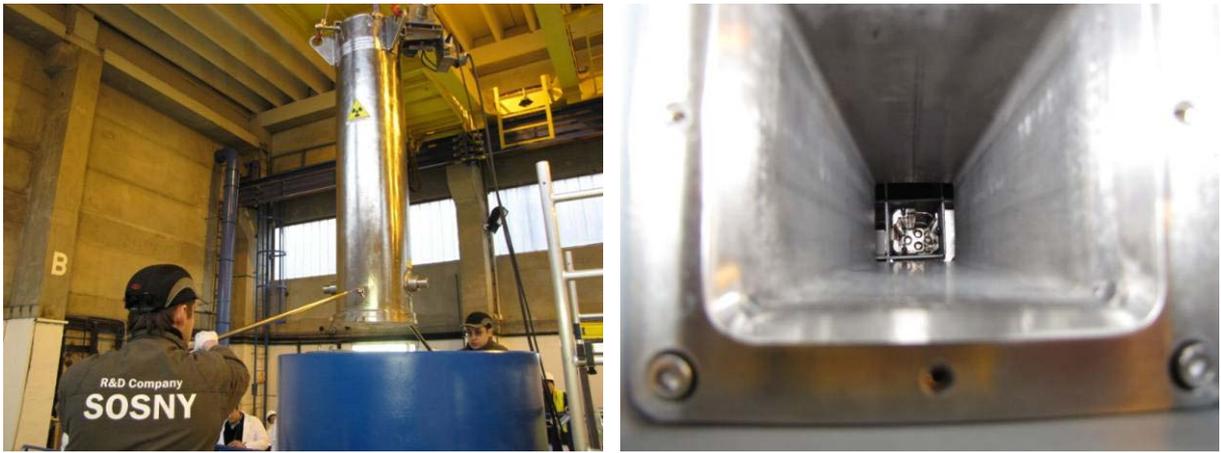
Fig. 5. Compatibility tests of VVR-M2 loading equipment and SKODA VPVR/M cask

Then the equipment was packed and delivered to UJV, Rez a.s., the Czech Republic, by road. Once installed at UJV, the VVR-M2 loading equipment was tested for compatibility with the SKODA VPVR/M cask. During the tests a support plate with an adaptor and positioners were installed onto the SKODA VPVR/M cask; the load units were transferred from the dry storage pool in the SKODA basket using a transfer cask.

The transfer cask with the load unit was installed on the adaptor with its plug having been removed, and the load unit was put into the SKODA VPVR/M cask basket using an electric winch. After removing the transfer cask, the plug was remotely installed in the adapter cell with a hook rod.

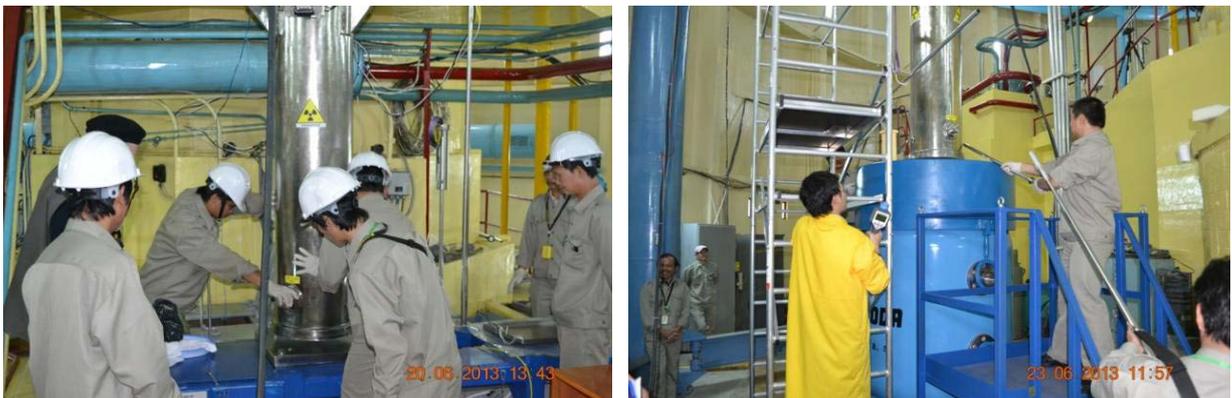
Fig. 6. Practicing in loading VVR-M2 SFAs into the shipping cask

Loading the VVR-M2 SFAs into the shipping cask followed the training. The operations took 4 working days. Once the spent fuel was loaded, the lid with the metallic o-ring seals was installed, the cask was evacuated, and a leak test was performed. The IAEA Safeguards experts supervised all the operations.

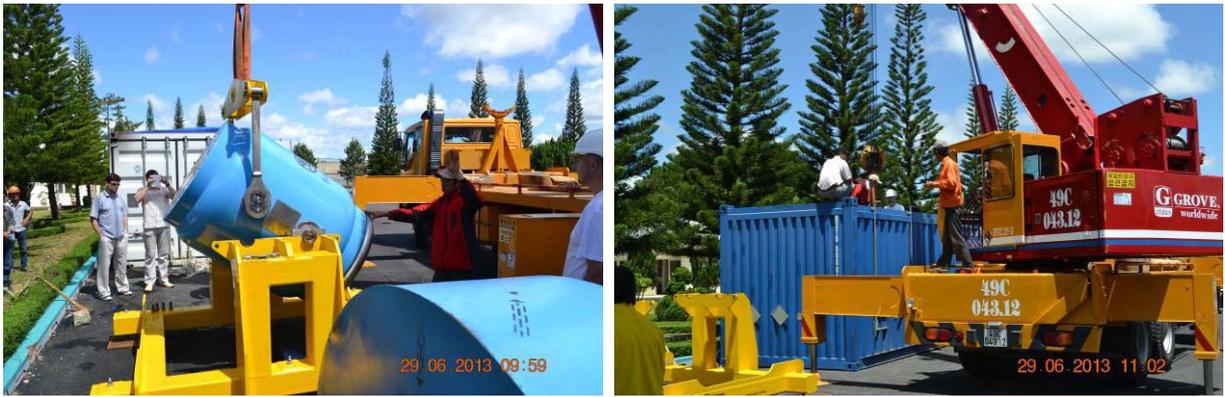
Fig. 7. Installing the SKODA VPVR/M cask in the filter, loading into ISO container

The forklift moved the dried SKODA VPVR/M cask containing 106 VVR-M2 spent fuel assemblies out of the reactor hall and placed it near the tilter. A truck crane installed the cask in the tilter to put on the lower shock absorber. After that, the SKODA cask was transferred into a special ISO container, where the upper shock absorber was put on it; then, the cask was tied down.

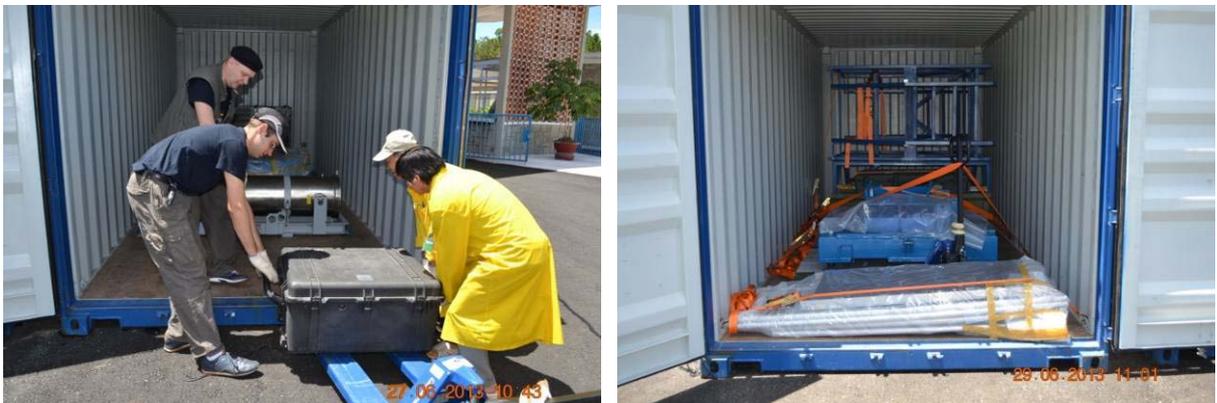
Fig. 8. Packing the equipment and loading into ISO containers.

Then the equipment was packed, loaded into the ISO containers and prepared for shipment to UJV, Rez a.s.

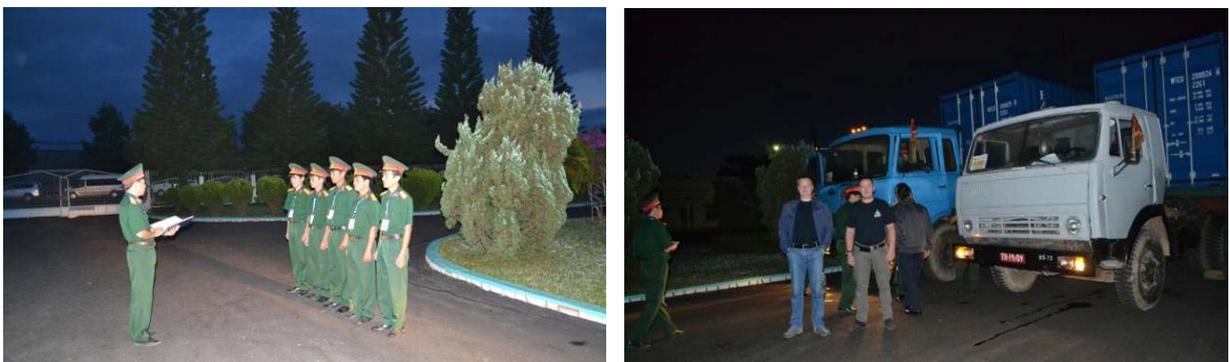
Fig. 9. Delivering the equipment from Dalat to Bien Hoa Airport

On June 30, 2013, 4 ISO containers with the equipment and tools started in the vehicle convoy from Dalat to Bien Hoa Airport. On July 1, 2013, an ISO container with the SKODA VPVR/M package was convoyed from Dalat to Bien Hoa Airport too. The convoy was escorted by the police and the military.

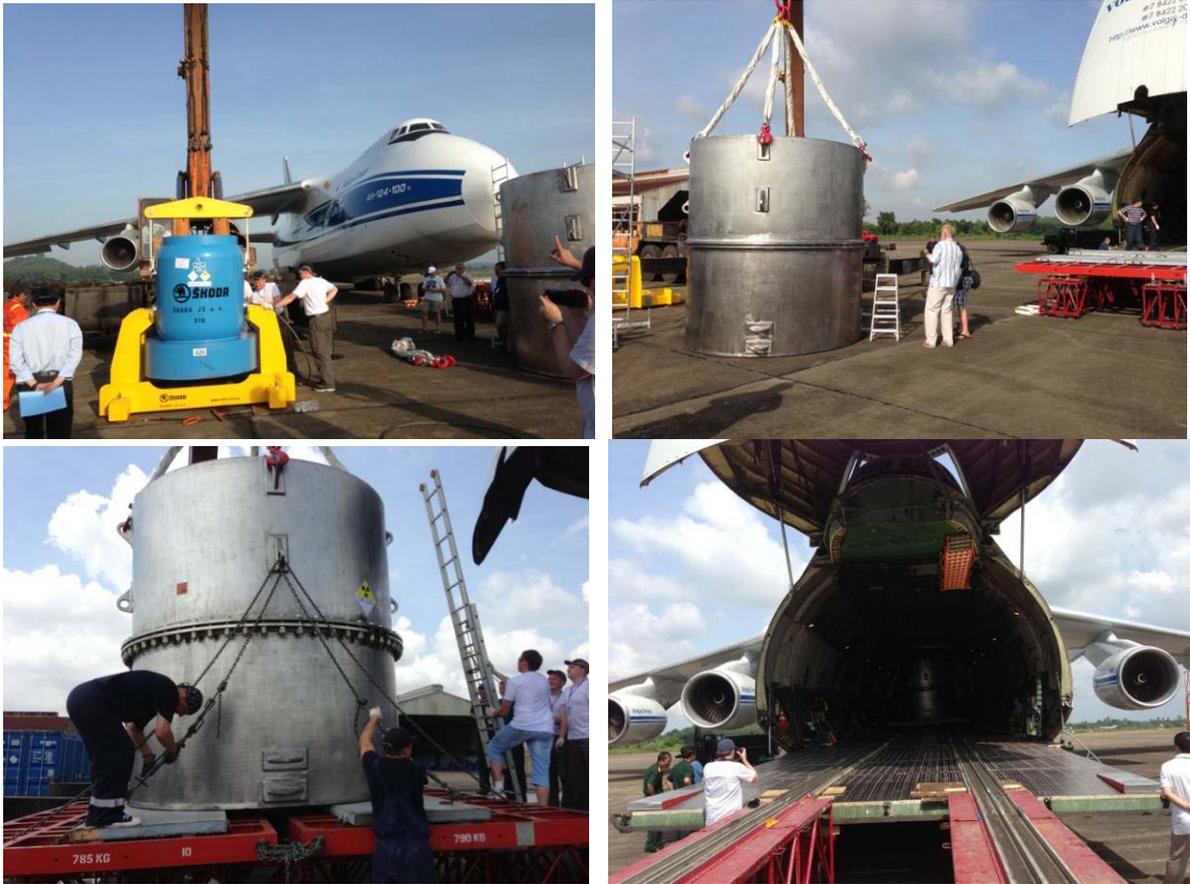
Fig. 10. Building up the TUK-145/C package and loading it into the aircraft

On July 1, 2013, an AN-124-100 aircraft delivered the energy absorbing container to Bien Hoa Airport. The handling equipment was deployed on the ground at the aircraft, and the SKODA VPVR/M cask and the energy absorbing container were joined together to build up the TUK-

145/C package. The TUK-145/C package was pulled into the aircraft with a winch, and the handling equipment was put into the ISO containers.
